Property Inspection Report

Inspection Prepared For: XXX XXX
Sample Report

Date of Inspection: 8/18/2022

| Sample Report, TX | |

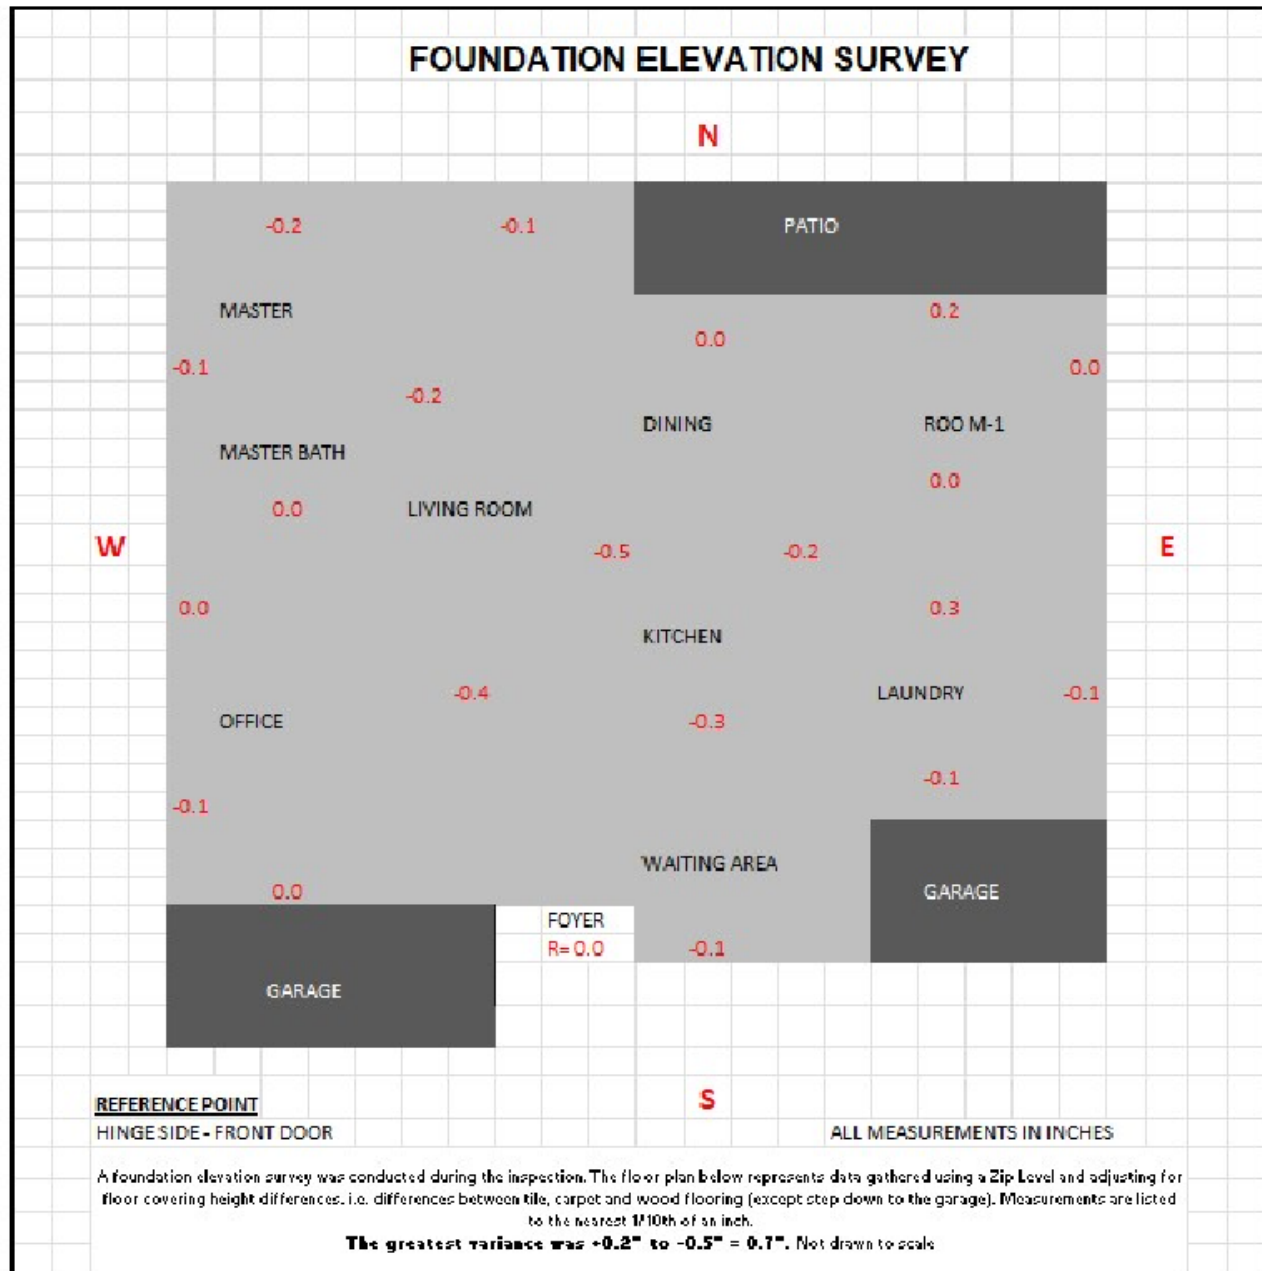
Foundation Elevation Survey

The foundation was visually inspected and a floor elevation survey was performed. A foundation elevation survey was conducted to evaluate the foundation and determine if further evaluation by a professional engineer is necessary. The floor plan below represents data gathered using a Zip Level and adjusting for floor covering height differences. i.e. differences between tile, carpet and wood flooring (except step down to the garage). Measurements are listed to the nearest 1/10th of an inch. The greatest variance was +0.2" to -0.5" = 0.7". Not drawn to scale

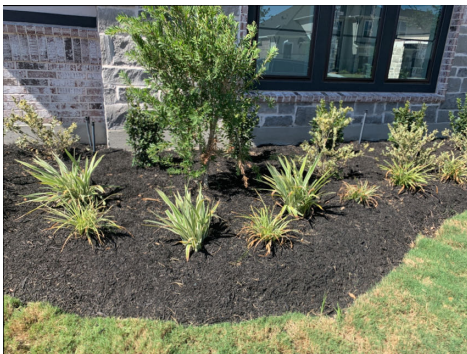
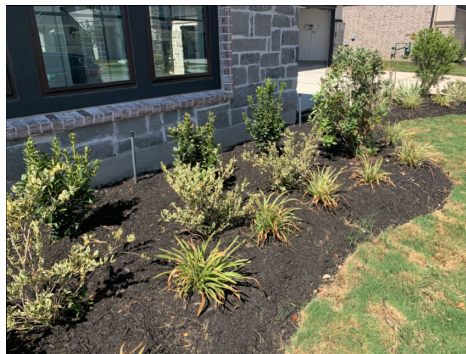
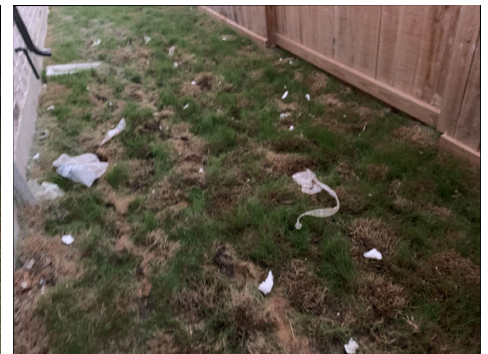
The home does not appear to have adequate drainage. This may cause erosion if not corrected. I recommend installation of additional french drain on the east exterior side.

The home does not appear to have adequate drainage; East exterior wall

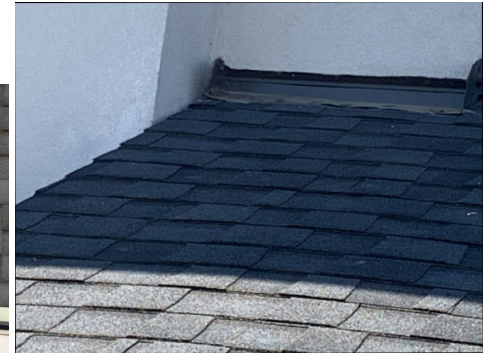
Flashings checked at the penetration

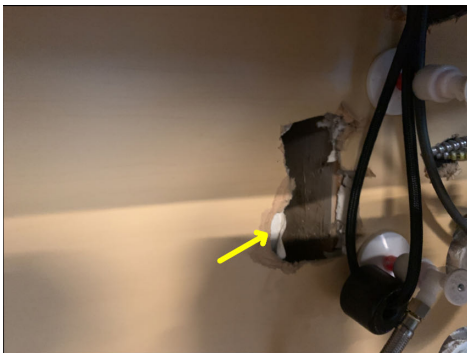
Wall opening under kitchen cabinet require repair

Recommend sealing all holes in interior walls / cabinets to reduce air and water infiltration.

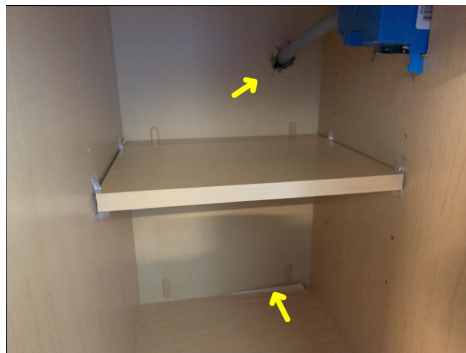
Opening and incomplete finishing; kitchen cabinet

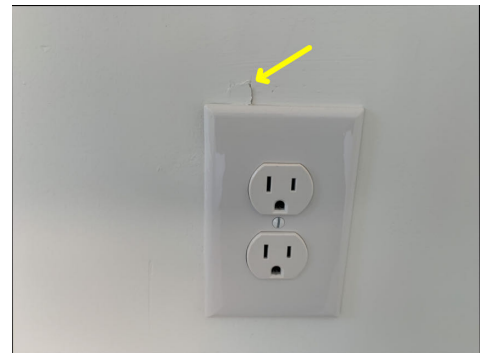
Wall opening require repair; Master Bedroom

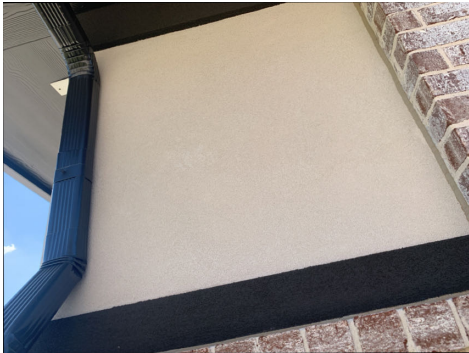
Stucco finishing on exterior wall

Recommend additional stucco intrusive inspection in near future to rule out the possibility of unseen/undetected/latent/hidden water damage behind the stucco exterior

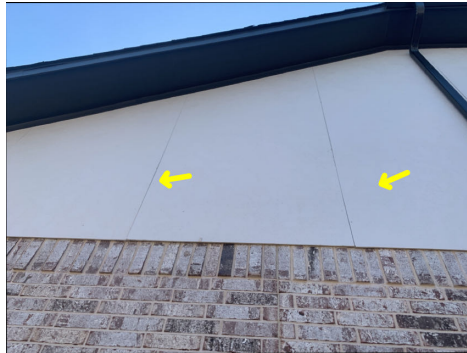
Observed opening/unfinished exterior wall on both (west/east) sides of the building

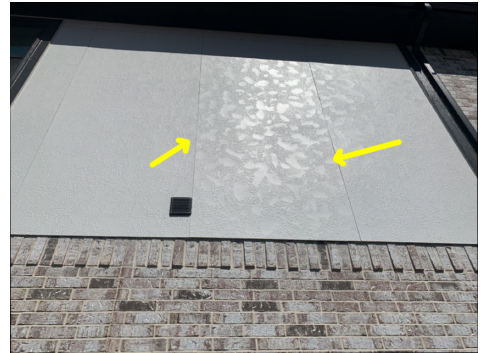
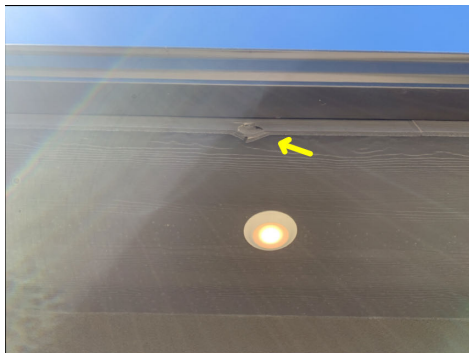
Wall opening/damage/crack at front trim above main garage

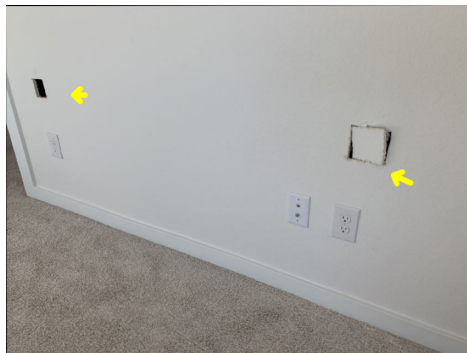
Wall openings require repair; level 2 - Bedroom 1

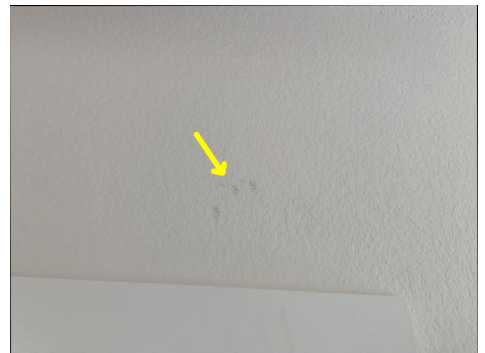
Observed minor scuffs and discoloration on some areas of interior walls. These are considered cosmetic issues. I recommend a qualified painting contractor prime and paint as desired.

Wall stains require paint touchups; Level 2 hallway and multiple locations

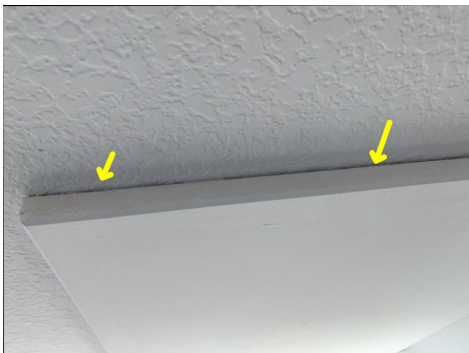
Caulking required to seal openings; Theater room

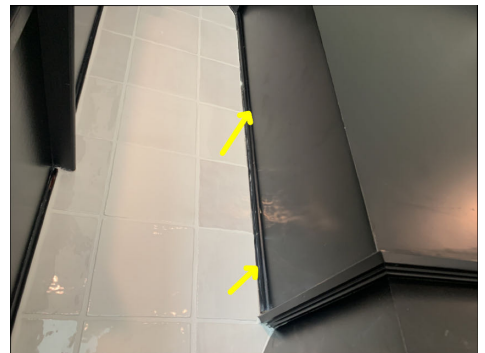
Caulking required to seal openings on both sides of the Range Hood

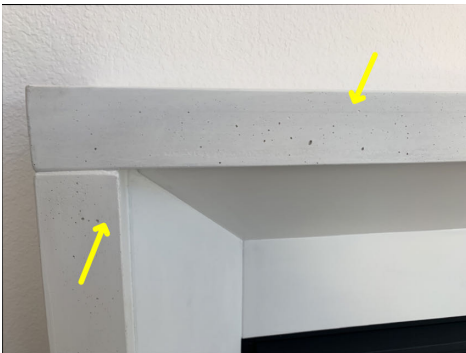
Unfinished surface on the fireplace frame require sealing openings

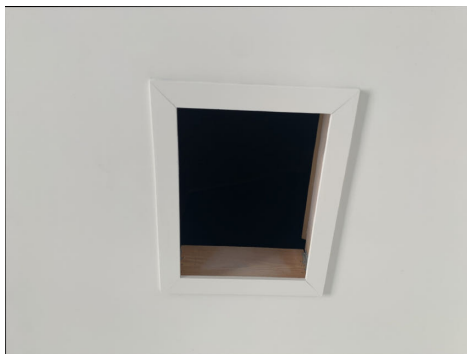
Missing hole cover in main garage

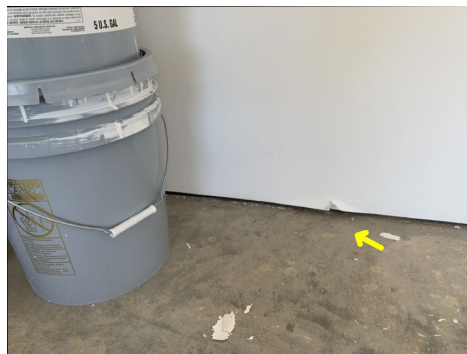
Opening in main garage floor require repair

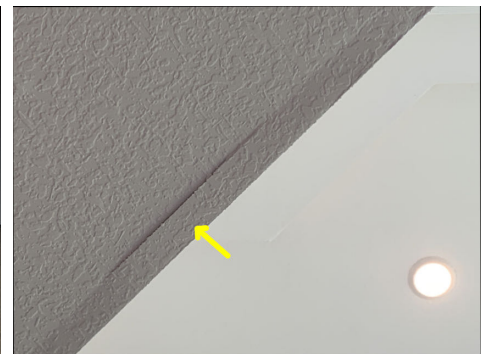
The drywall on the ceiling reveals tape lines. A qualified person should repair or replace as needed.

Tape revealing require repair; living room/kitchen ceiling area

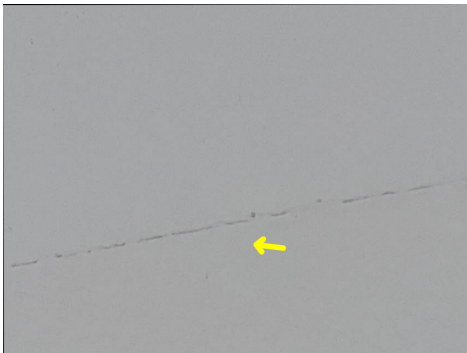
Revealing tape line require caulking; Level 2 Room 1

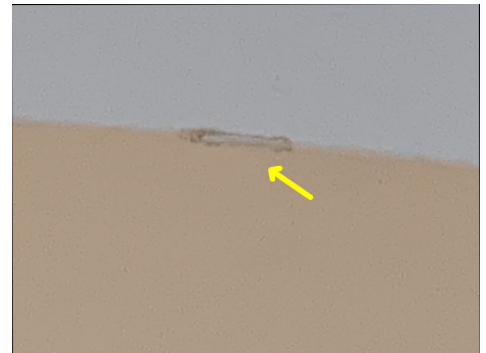
Wall damage on front arch decking require repair

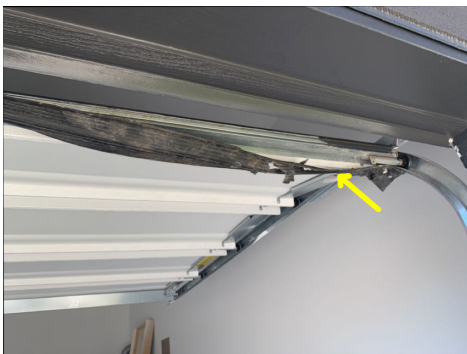
The weather-stripping at the bottom of the overhead garage door is damaged and repairs or replacement may be necessary.

Main entry garage door weather-stripping damaged

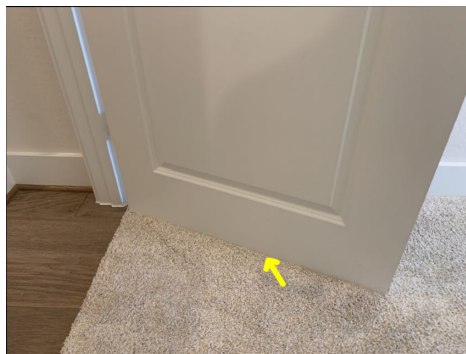
Entry door stuck and unable to open; Level 1 Bedroom 1

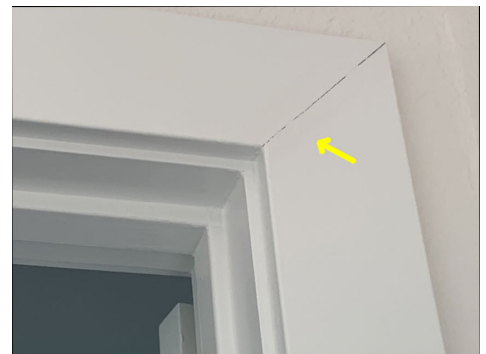
Bathroom entrance door frame and the door lock require repair; Master bathroom

Bathroom entrance door frame require repair; Master bathroom

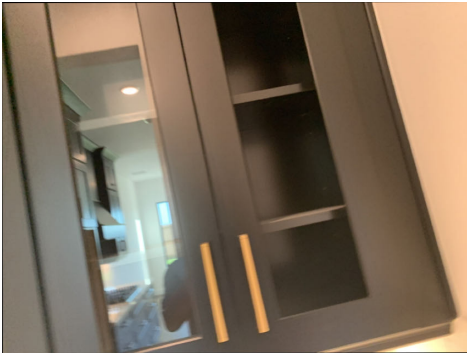
Glass covering on storage cabinet missing; Kitchen area

Glass covering on storage cabinet missing;
Kitchen area

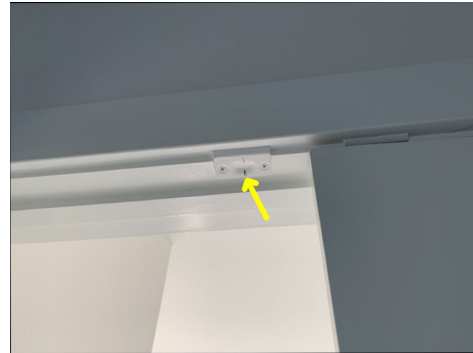
Bathroom entry door not closing properly; master
bathroom

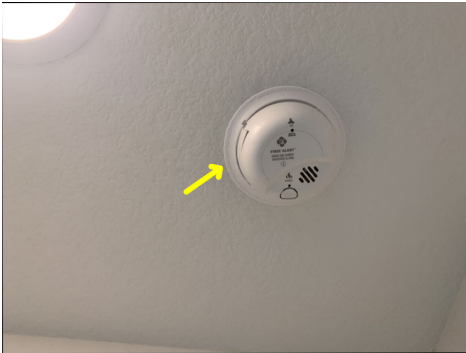
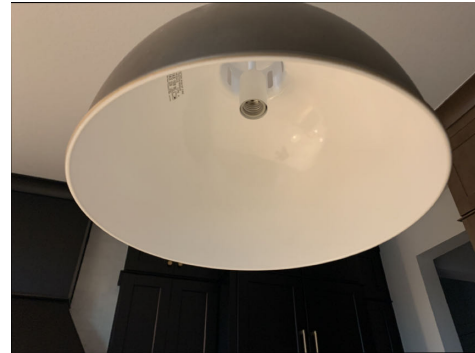
Light bulb in kitchen highland lamp holder not working, require repair.

Lamp holder missing bulb; Kitchen faucet

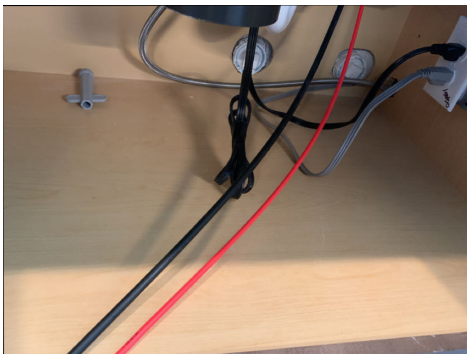
Filtered water connection installation not completed

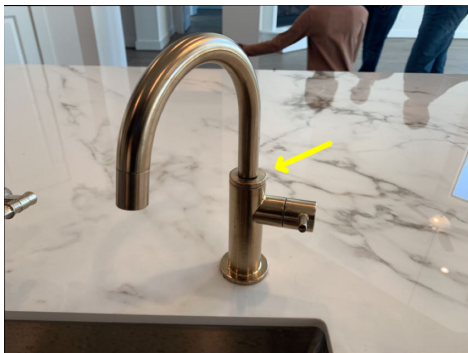
Faucet loose, not installed, not secured properly.

Loose connection on kitchen sink faucet

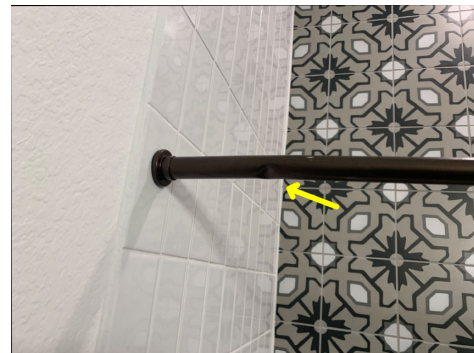
Damage/dent observed on the shower curtain rail;
Level 1 Room 1

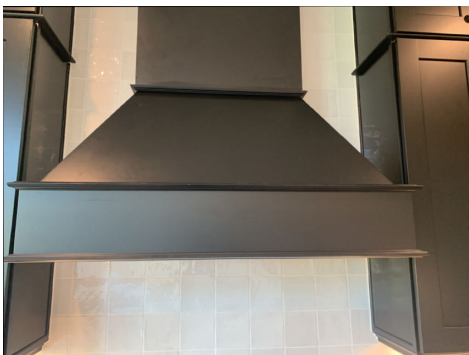
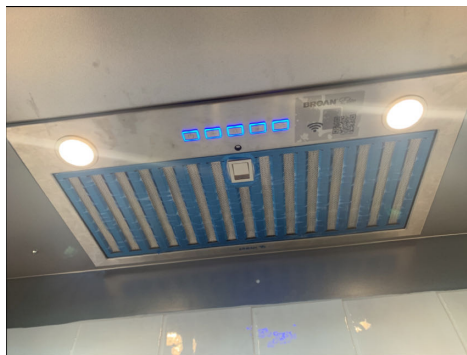
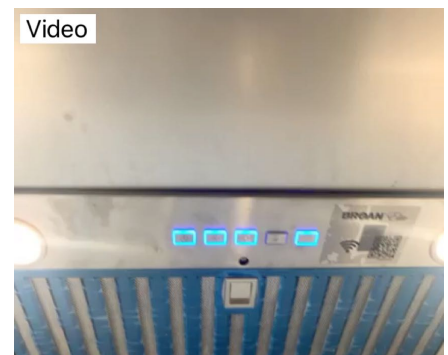
Unit has excessive vibration / noise when operated. The unit requires proper installation to eliminate the noise and vibration.

Observed high noise level and vibration
