Property Inspection Report

Inspection Prepared For: XXX XXX
Sample Report

Date of Inspection: 8/18/2022

| Sample Report, TX | |

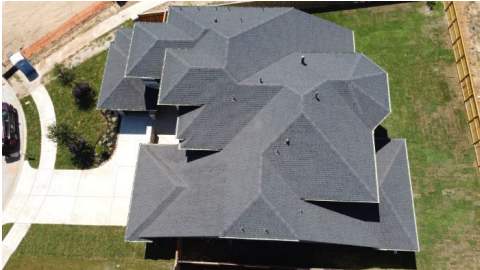
A drone was used to inspect the roof

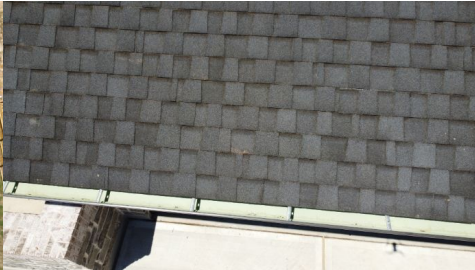
Roof gutters in good condition

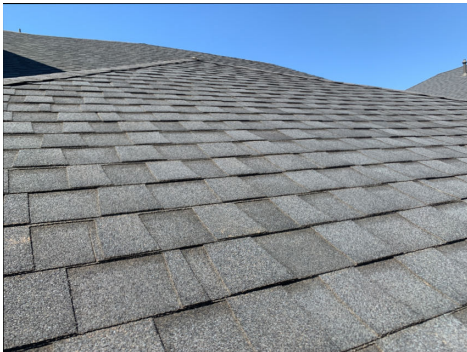
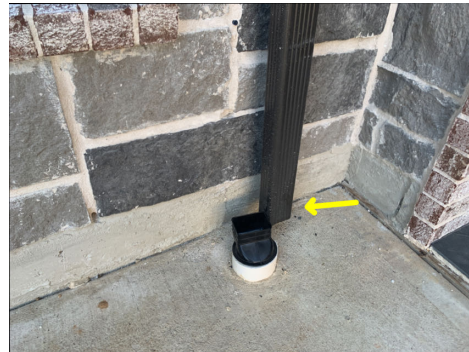
Incomplete downspout installation

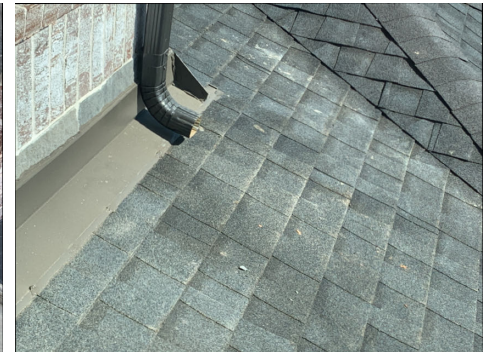
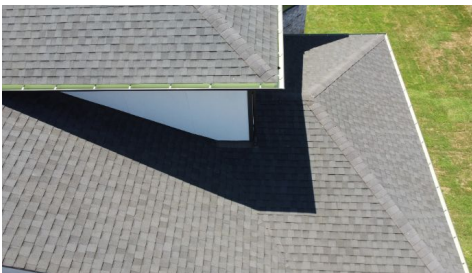
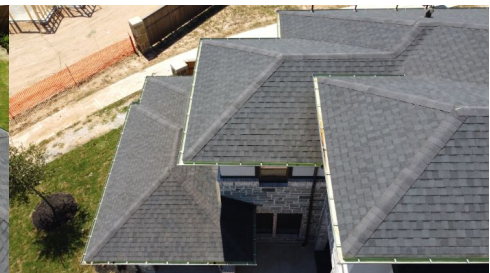
Ridge and valley checked

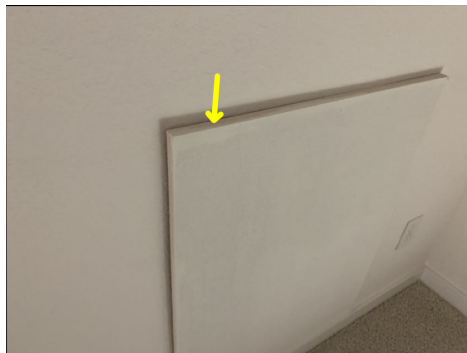
Caulking required to seal openings; Level 2 Room 1

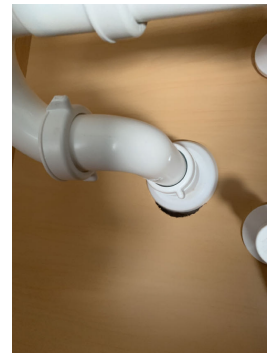
Wall openings at plumbing connections require sealing; multiple locations

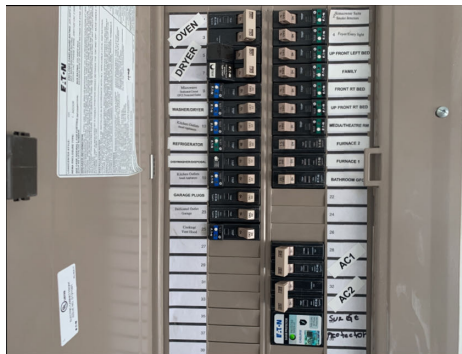
Electrical panel breakers properly identified

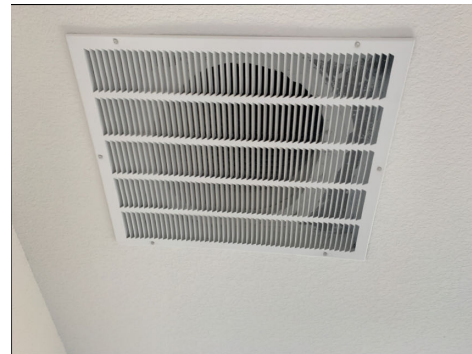
Filter is located in the hall area wall

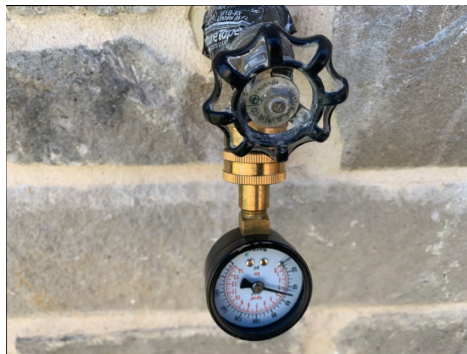
Static water pressure is 50 PSI

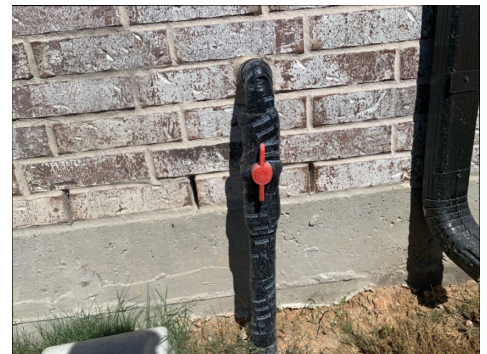
Water Shut off valve located on west side of building

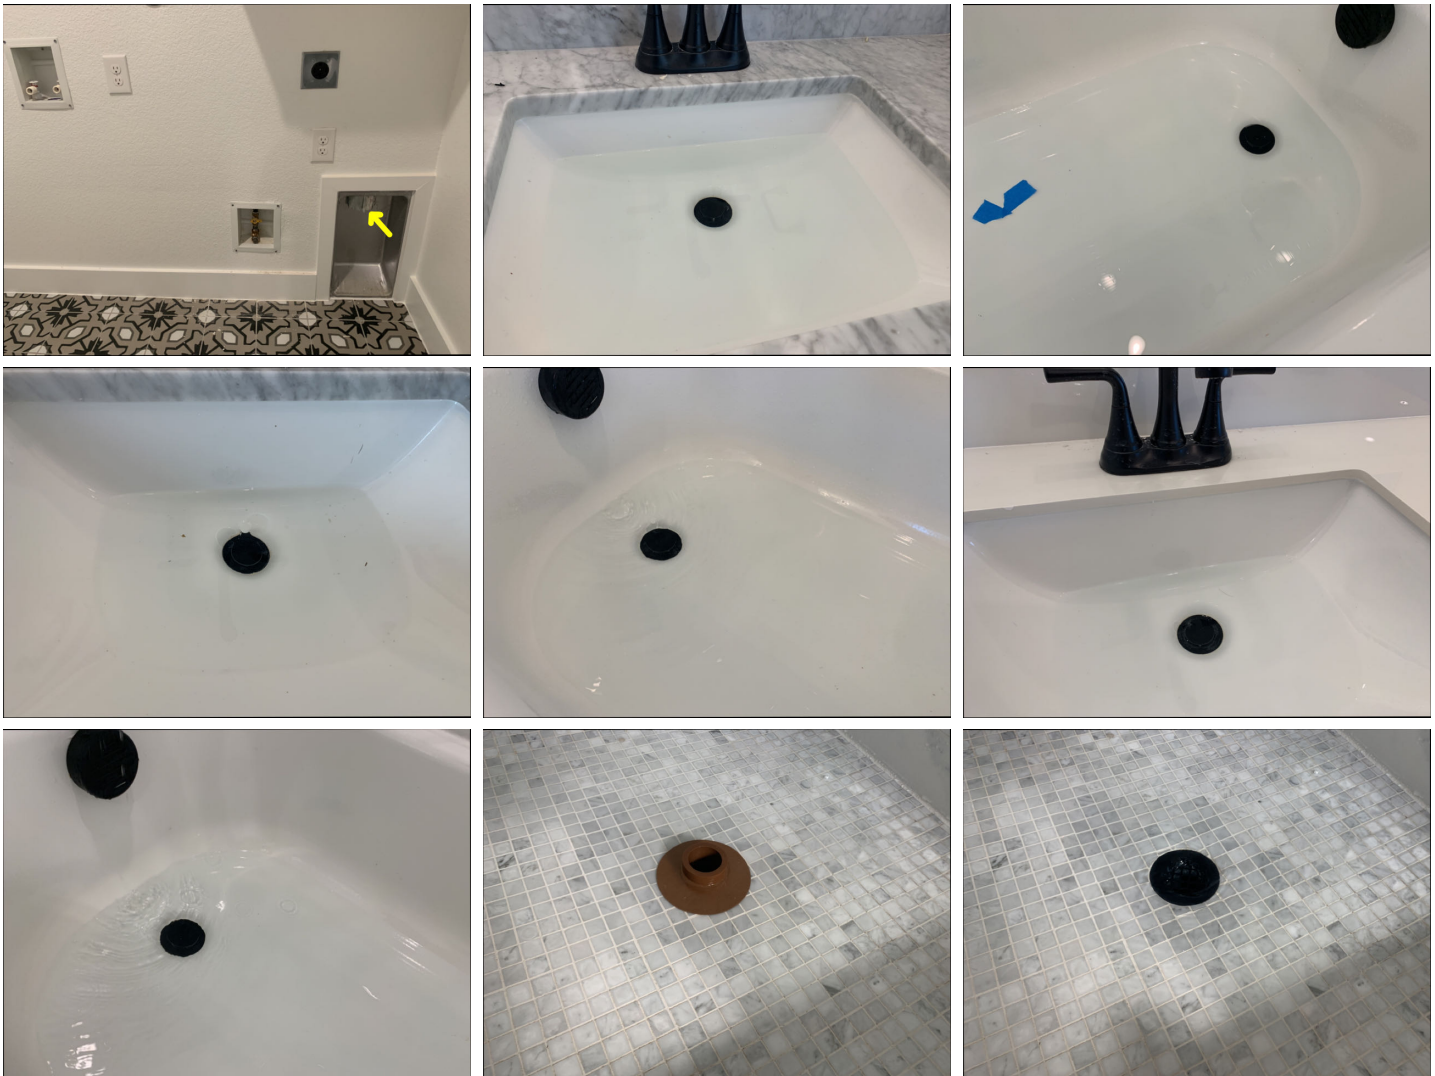
Shower pan test in operation

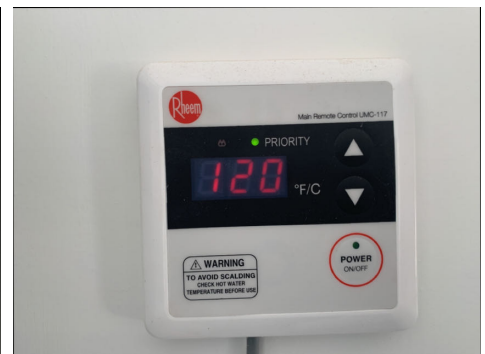
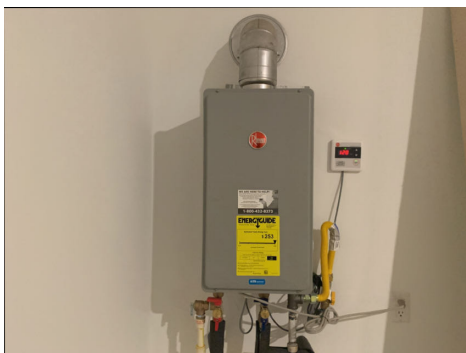
Water heater located in the main garage

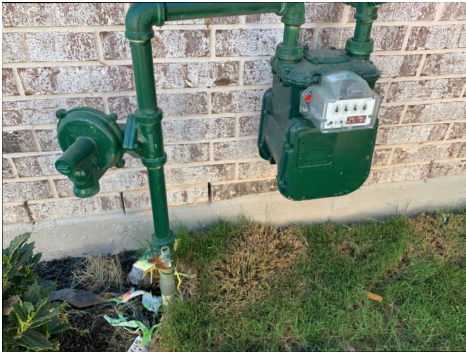
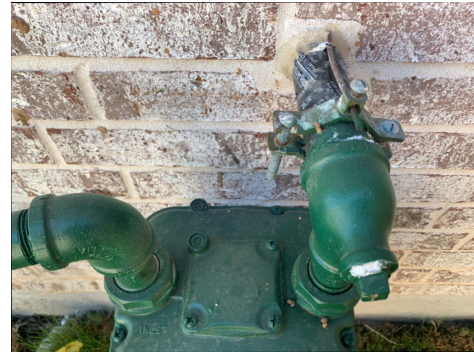
Gas meter located on East exterior wall

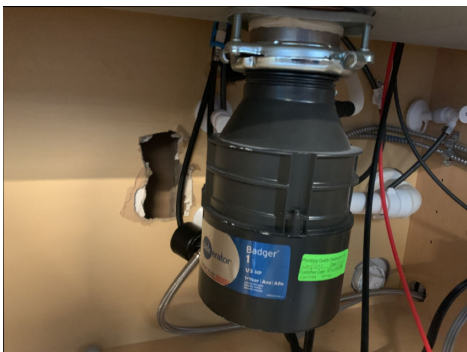
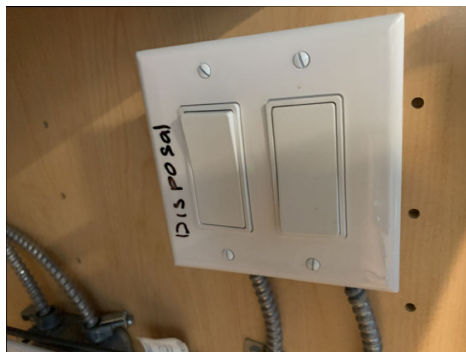
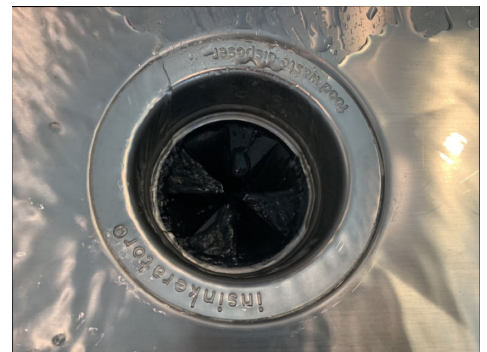
Disposal in operation

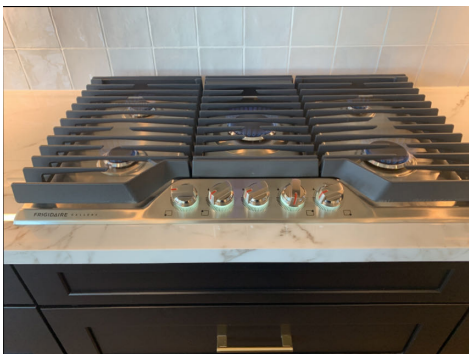
FRIGIDAIRE cooktop in operation

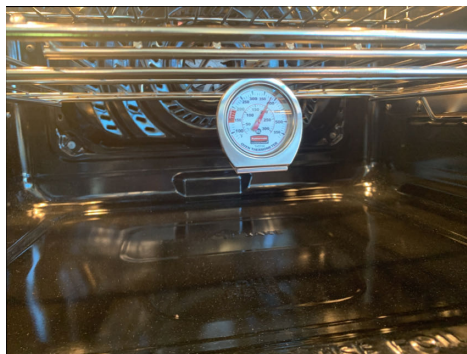
FRIGIDAIRE Oven in operation

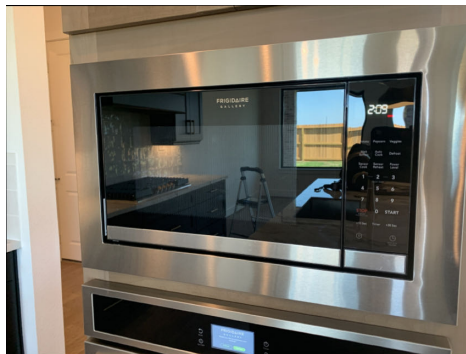
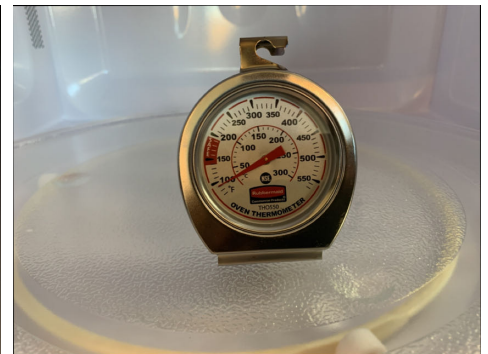
FRIGIDAIRE Microwave in
operation

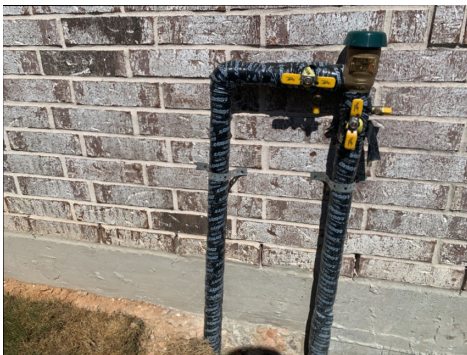
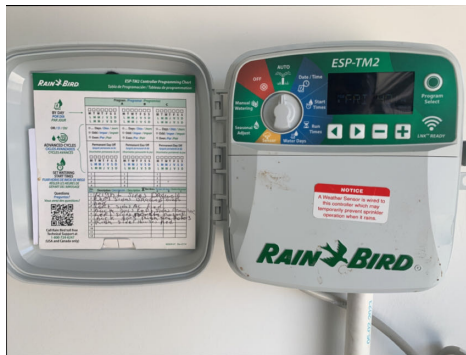
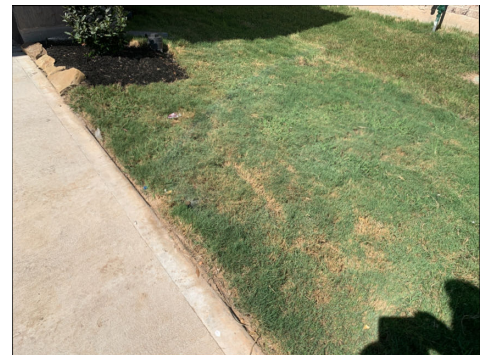
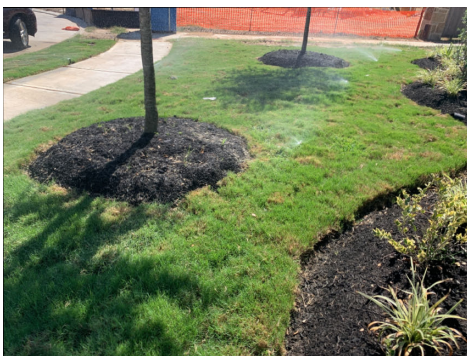
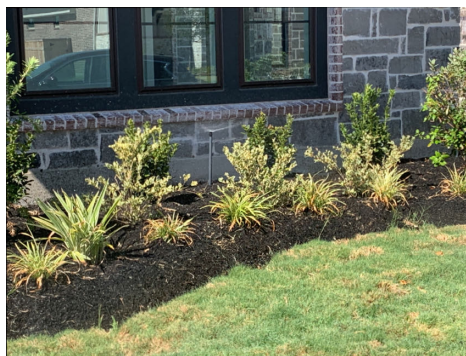
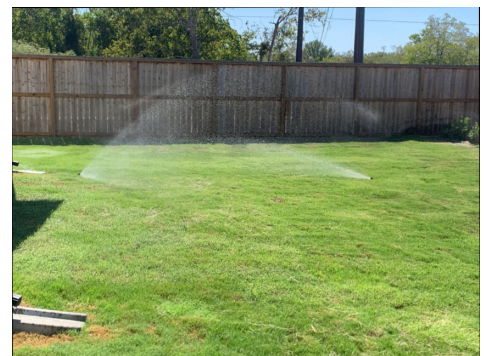
Sprinkler system in operation
